Low-Earth Orbit Flight Test  
of an Inflatable Decelerator

# Tracking and Recovery of the LOFTID RV

**AIAA SciTech Forum  
8-12 January 2024**

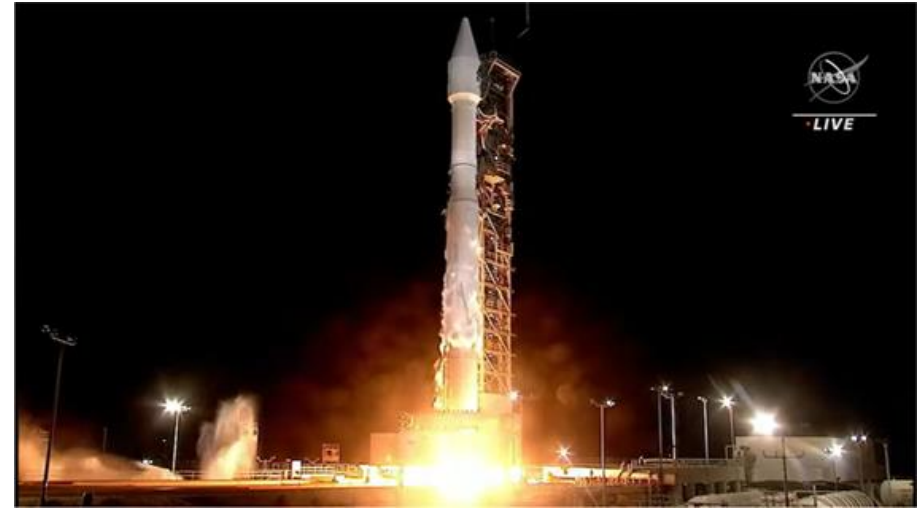
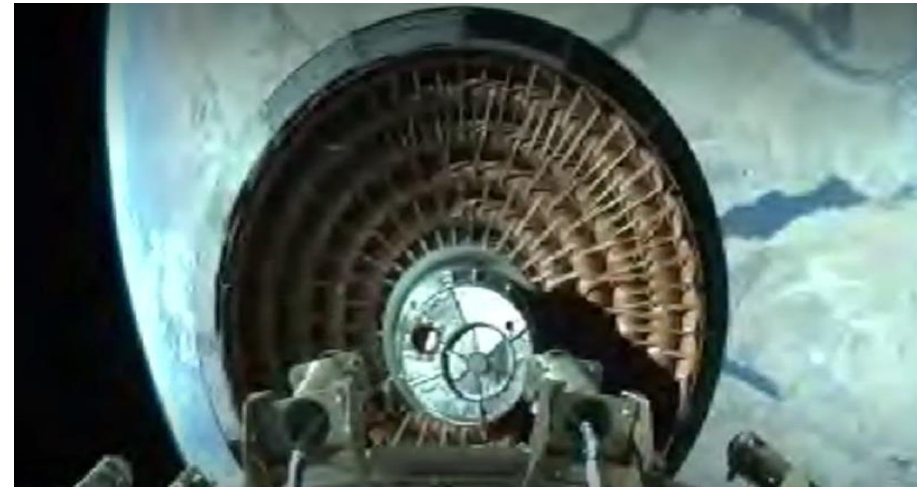
- **LOFTID: Low-Earth Orbit Flight Test of an Inflatable Decelerator**
- **Largest blunt-body yet flown: 6m diameter**
- **Launched late on November 10, 2022, from Vandenberg Space Force Base**
- **Splashed down 2 hours 5 minutes later, 550 miles east of Honolulu**
- **Successfully demonstrated inflatable aeroshell technology at scale and conditions relevant to Earth and Mars EDL**
- **Hardware recovered after splashdown**

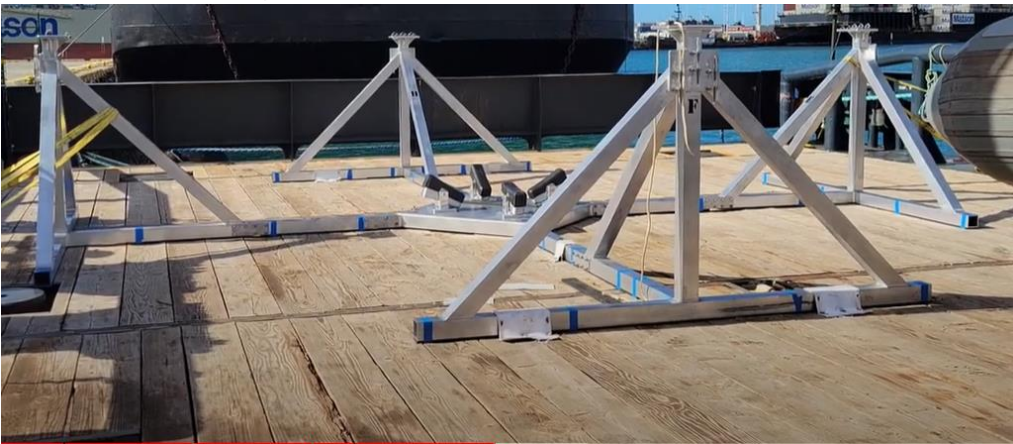
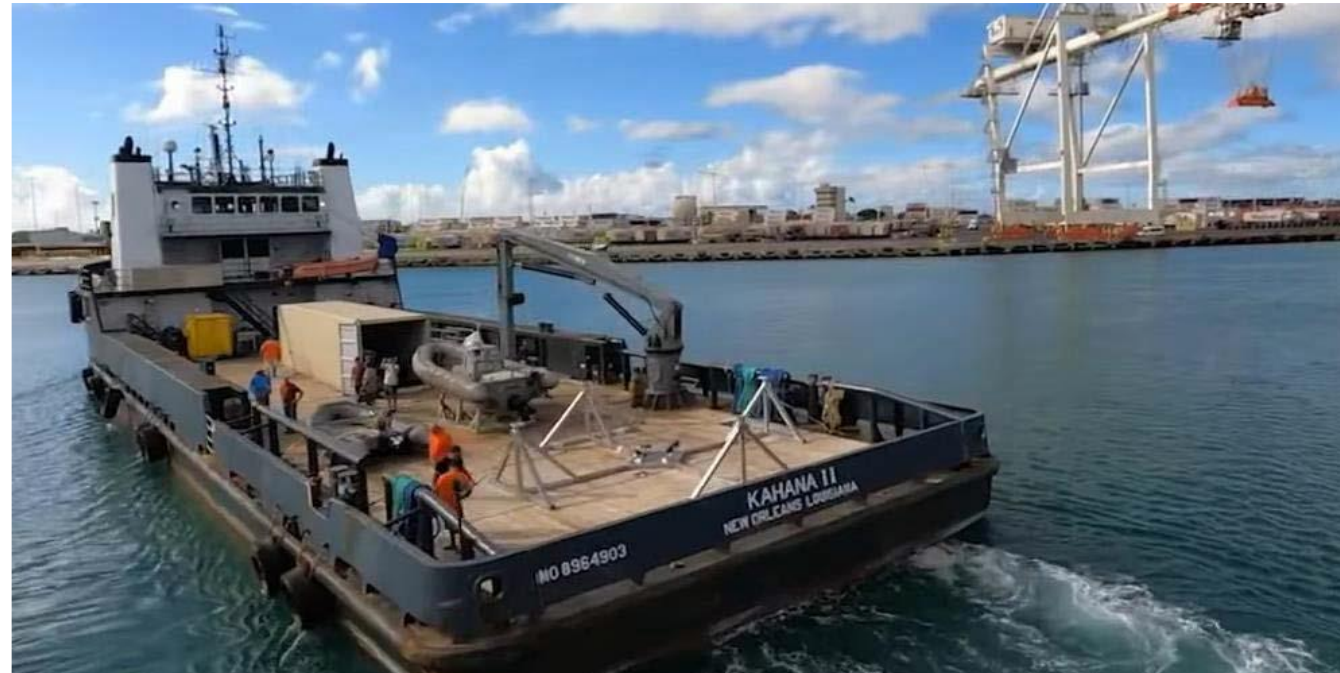
# Recovery Ship

- Rented by United Launch Alliance, our partner on LOFTID.
- Evaluated several ships – including Coast Guard, NOAA, & Univ. of Hawaii – but most ships don't have enough open deck space for the 20x20' recovery stand that'll hold the RV.
- Offshore supply vessel Kahana II:
  - 220' long with a 138x37' flat cargo deck
  - Onboard crane rated for 3 tons at full extension of 40'
  - 2 small boats for recovery operations
- 10-knot cruising speed
  - Leave Honolulu 2½ days before launch
- Also arranged for pier & warehouse space at University of Hawaii Marine Ops Center

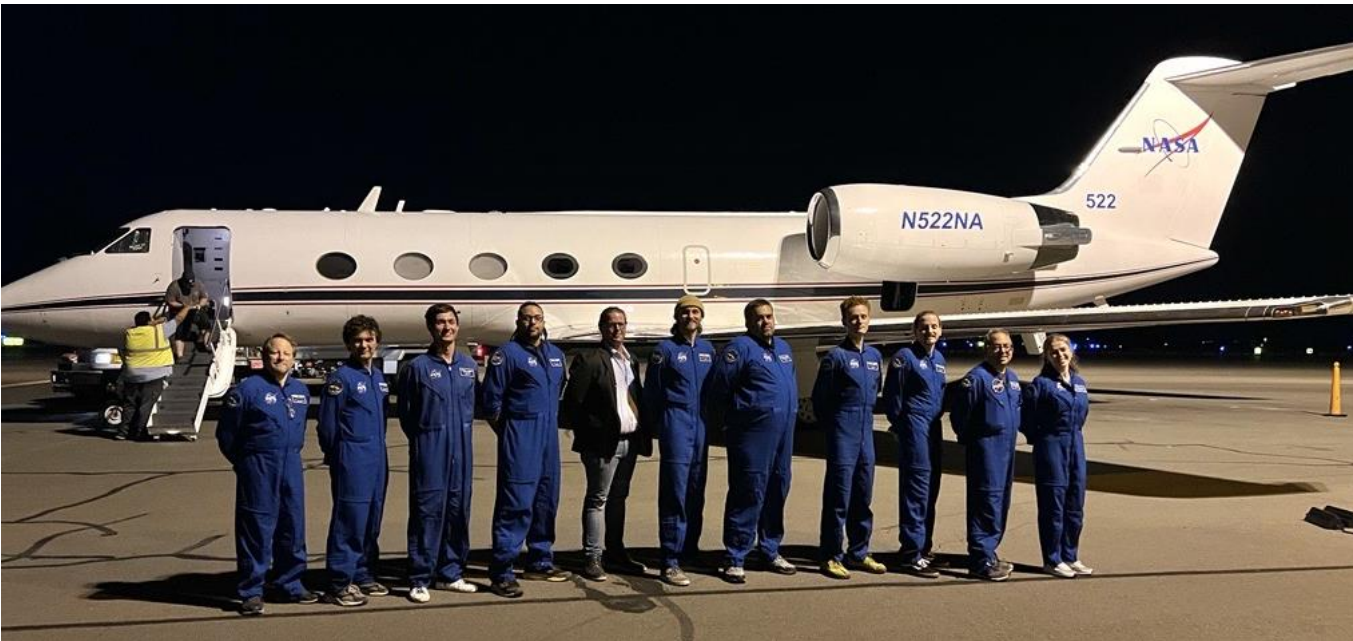
# Airborne Imaging of Reentry

- Scientifically Calibrated In-Flight Imagery (SCIFLI) team provided remote imaging of LOFTID RV during the reentry heat pulse.
- Flew seven science instruments, including radiometers and spectrometers, on gimballed mounts on NASA Gulfstream IV outside RV's splashdown ellipse.
- Provided time-resolved thermal / spectral imagery.
- Available to provide contingency help locating RV.

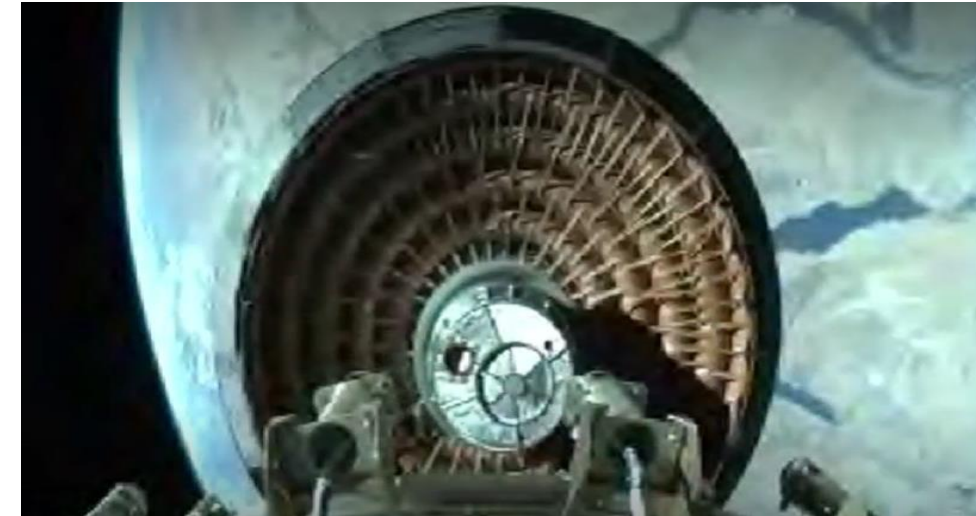
- Recovery team, prepositioned at splashdown site, watched Atlas launch online (via KSC Starlink terminal).
- Due to a late hold in the countdown, launch occurred near the middle of the window, so we repositioned the recovery ship 6 miles west, outside the splashdown ellipse.
- Did not receive RTB data as scheduled after separation from Centaur...
- After several uncomfortable minutes, video from Centaur showed successful inflation and release of LOFTID RV.
- Later analysis showed that the final launch slip had moved reentry into a gap between the closest Iridium satellites.

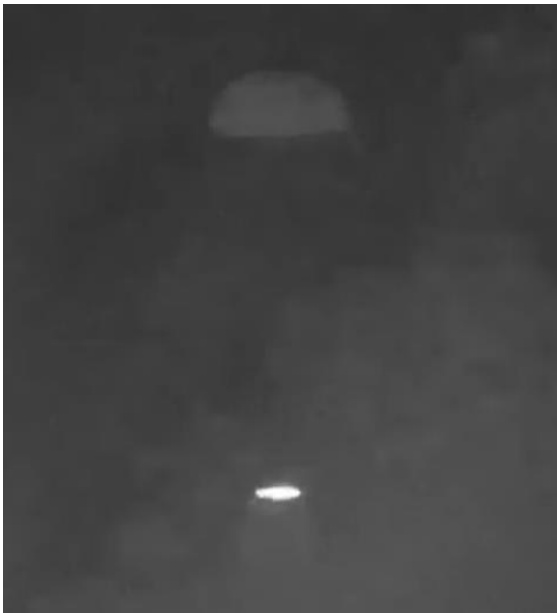
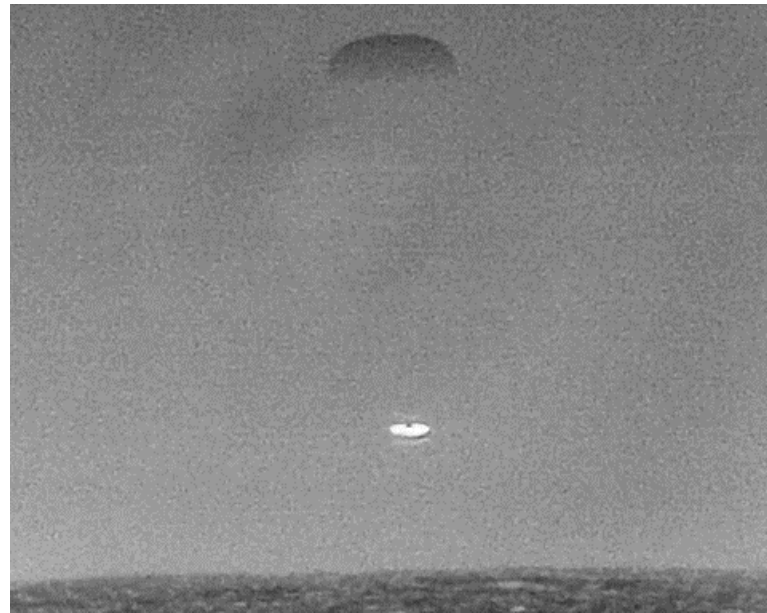
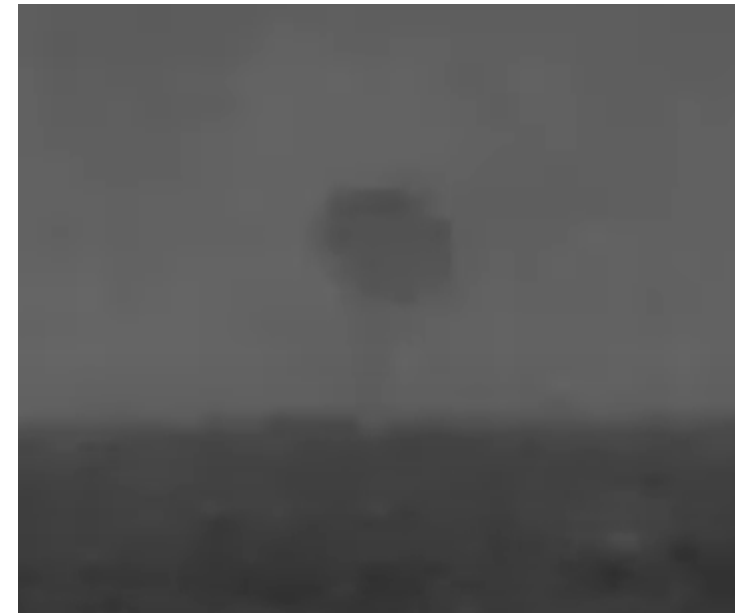
# Splashdown!

- The weather was excellent for recovery: calm seas and mostly clear skies.
- With the GPS data providing a direction vector, the recovery team was able to spot the lights on the RV, descending slowly under parachute. The IR camera team tracked the RV to splashdown.
- Navigation became simple once the RV was in sight – the ship headed for the light in the sky! The RV disappeared over the horizon briefly at splashdown but came back into view as the ship approached.

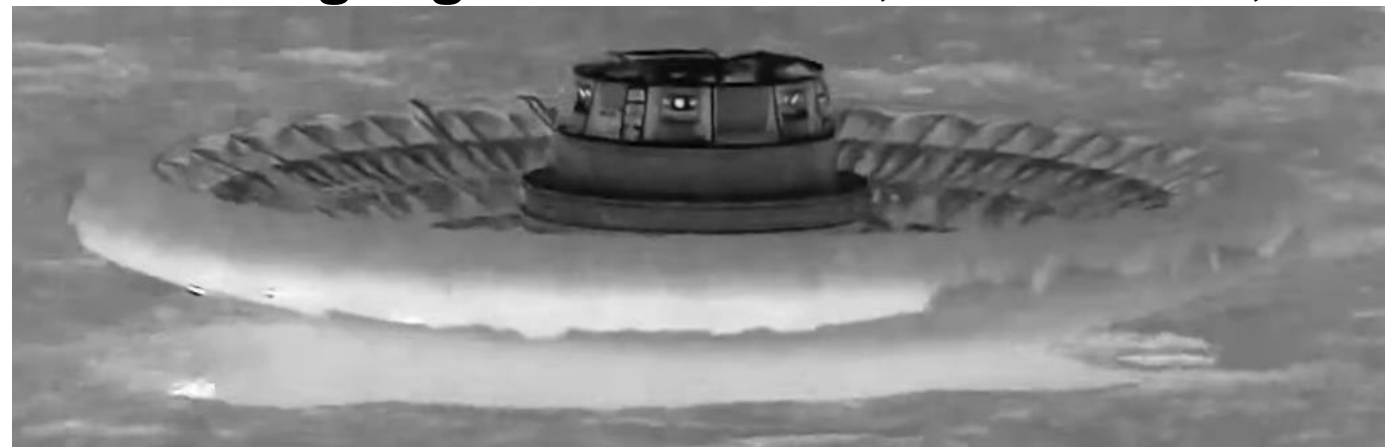
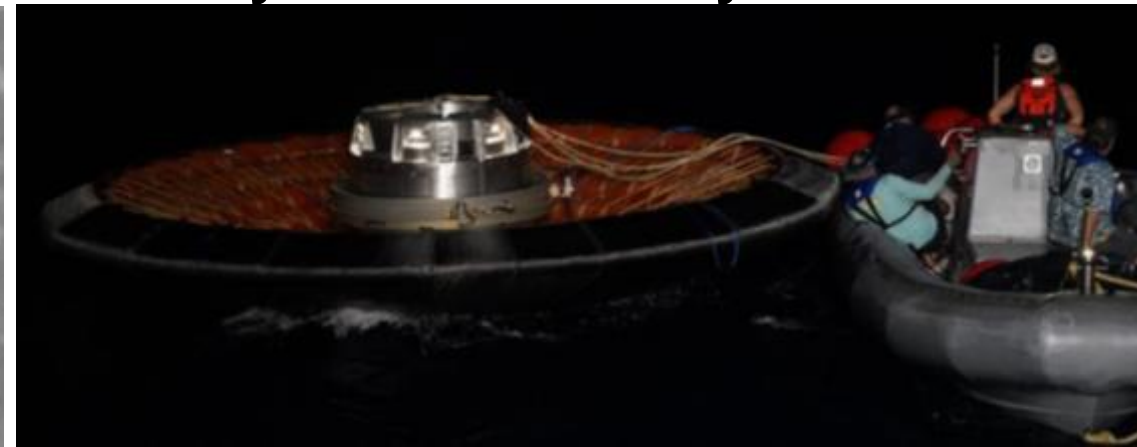
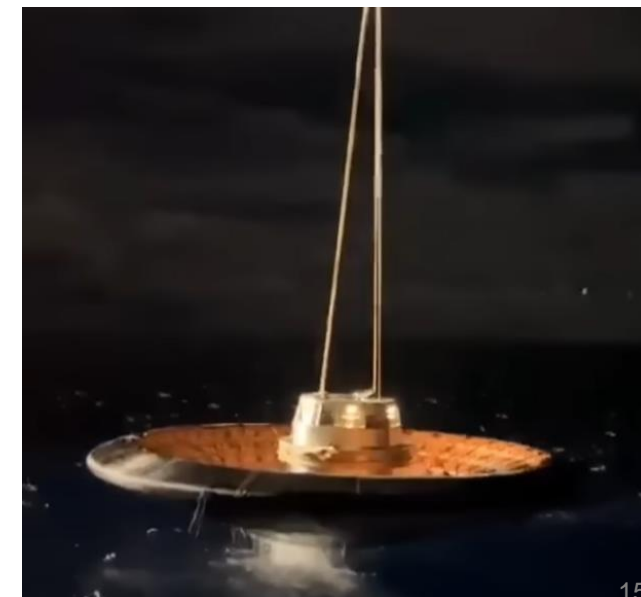
## Securing the RV

- Ship reached the RV about an hour after splashdown. RV was in great shape, floating high in the water, nose-down, and recovery went smoothly.

- Ship deployed a small boat with three members of the recovery team and a pilot from the ship's crew.
- Attached the parachute riser legs to a lifting ring for easy connection to the ship's crane, and attached tag lines that were needed to stabilize the lift.
- Towed the RV to the ship, connected the crane, and lifted the RV into the recovery stand on the ship's deck.

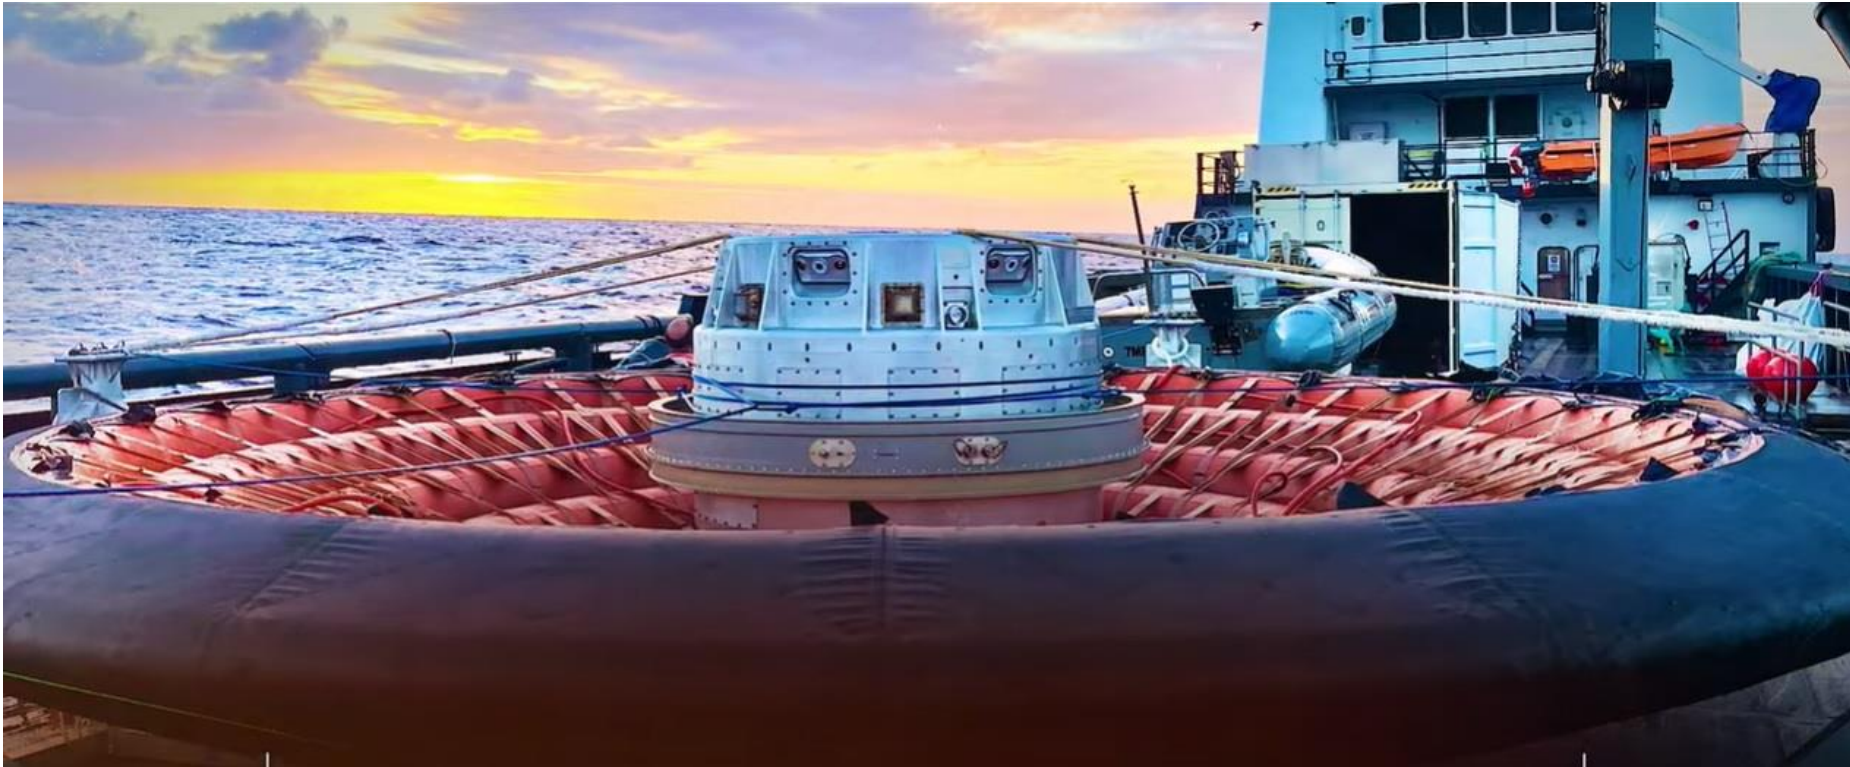
## Securing the EDR

- After securing the RV in the recovery stand, the ship headed for the EDR's GPS coordinates, waiting an extra hour for sunrise to avoid running it over in the dark.
- Once the EDR was spotted, the ship maneuvered close, and EDR was retrieved from the water with a fishing net on 30' pole before returning to port.

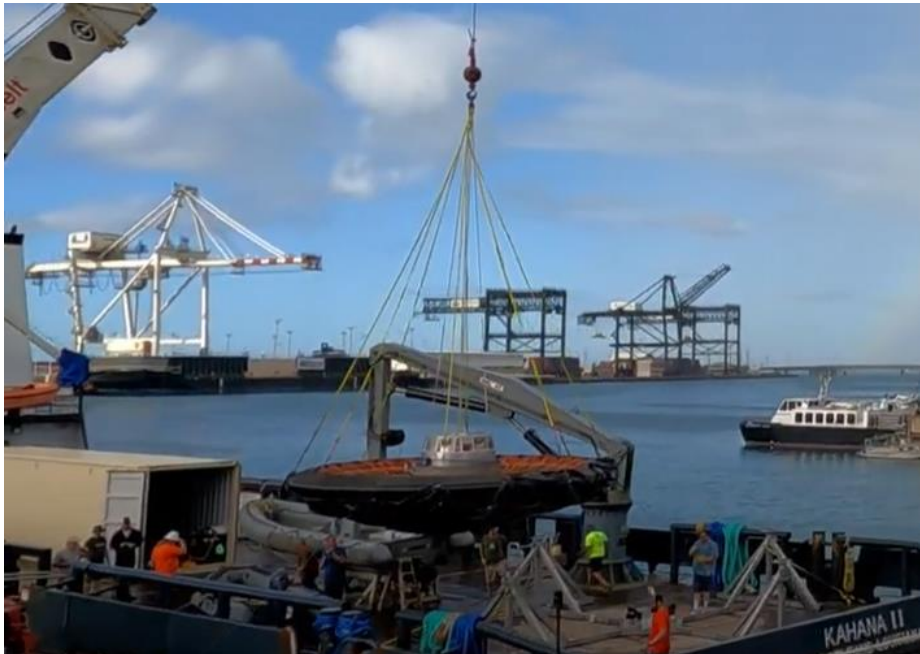
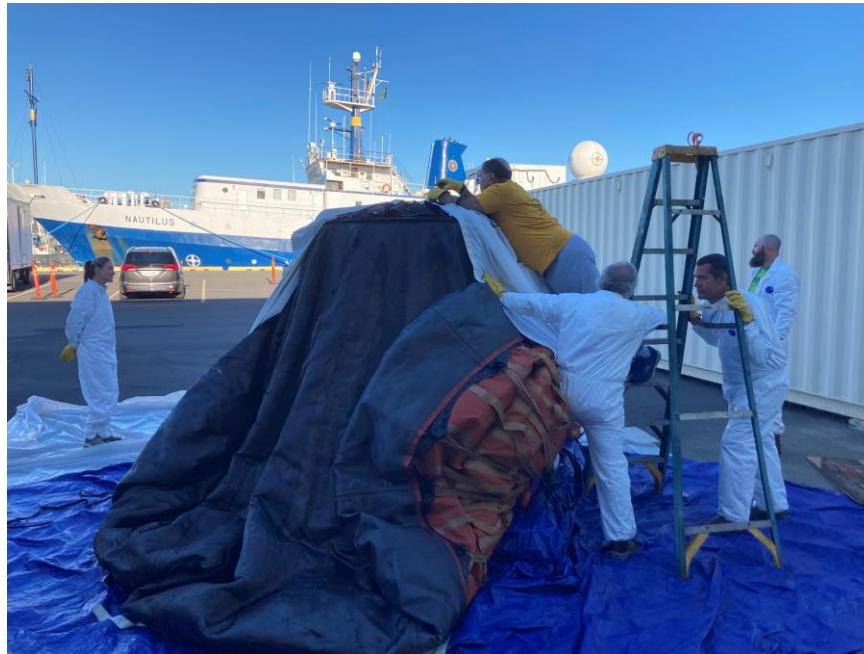
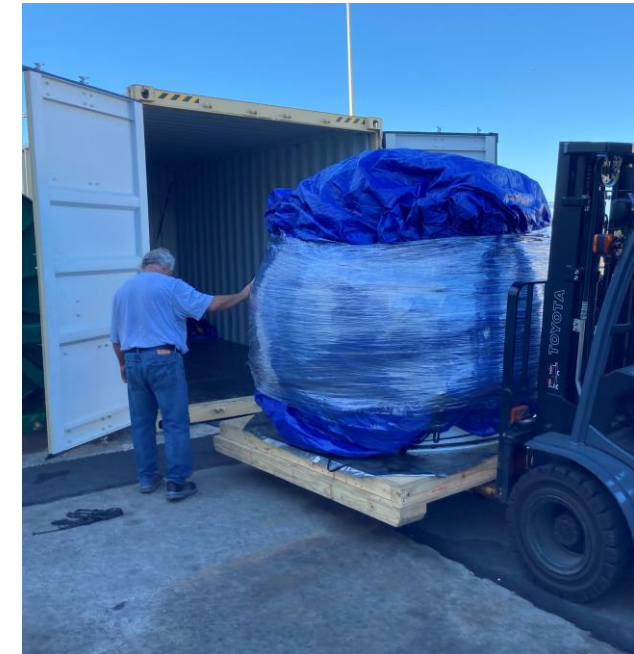
# Processing in Port

- Once in port, craned RV and recovery equipment ashore at the University of Hawaii Marine Operations Center / Honolulu pier 34.
- Closely inspected & photographed the RV.
- Downloaded flight data from ejectable recorder & RV internal recorder, and removed the individual cameras to download the uncompressed video from them.
- Deflated the aeroshell and packed everything back into the shipping containers to go home to Langley.
